Contract #: 04-0120F4Cty: SF/ALA Rte: 80 PM: 13.2/13.9File #: 1.28**WELDING INSPECTION REPORT****Resident Engineer:** Casey, William**Address:** 333 Burma Road**City:** Oakland, CA 94607**Report No:** WIR-026678**Date Inspected:** 09-Nov-2011**Project Name:** SAS Superstructure**OSM Arrival Time:** 700**Prime Contractor:** American Bridge/Fluor Enterprises, a JV**OSM Departure Time:** 1530**Contractor:** American Bridge/Fluor Enterprises, a JV**Location:** Job Site**CWI Name:** As noted below.**CWI Present:** Yes No**Inspected CWI report:** Yes No N/A**Rod Oven in Use:** Yes No N/A**Electrode to specification:** Yes No N/A**Weld Procedures Followed:** Yes No N/A**Qualified Welders:** Yes No N/A**Verified Joint Fit-up:** Yes No N/A**Approved Drawings:** Yes No N/A**Approved WPS:** Yes No N/A**Delayed / Cancelled:** Yes No N/A**Bridge No:** 34-0006**Component:** OBG Component**Summary of Items Observed:**

13W/14W "D" Plate

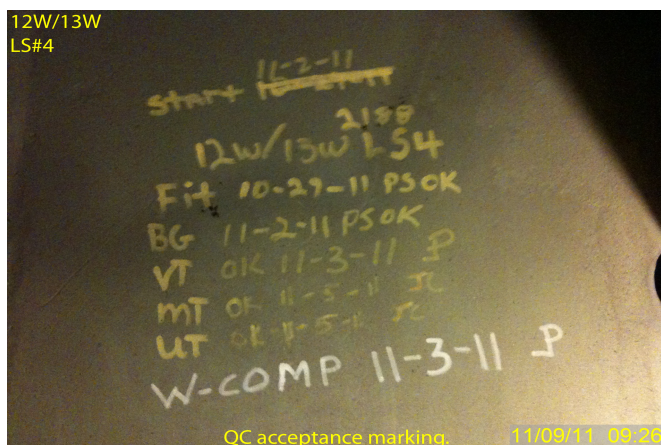
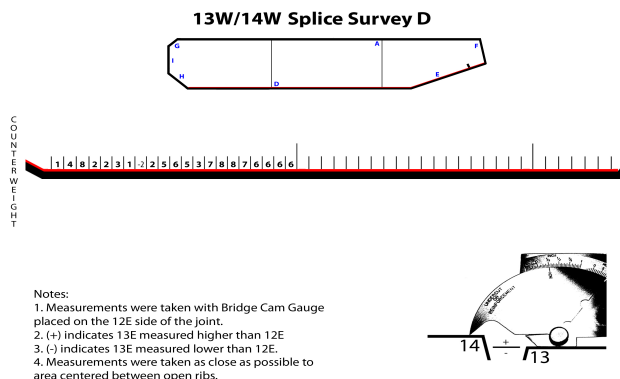
This QA performed a planar alignment survey of the 13W/14W "D" bottom plate butt joint (B-U2-S). Off-set measurements were taken with the Bridge Cam Gauge placed on the 13W portion of the connection.

(+) indicates that 14W was recorded as being higher than 13W.

(-) indicates that 14W was recorded as being lower than 13W.

All measurements were taken as close as possible to the area directly centered between the adjacent open ribs.

Due to a plate thickness mis-match of 5mm, up to 8mm misalignment is allowed at this joint. Please see attached sketches for details of survey on 13W/14W.
